ENGINEERING GEOLOGICAL INVESTIGATIONS
AND HAZARD ASSESSMENT
FOR THE
PICTON, WAIKAWA AND SHAKESPEARE BAY AREA,
MARLBOROUGH SOUNDS.

A thesis
submitted in partial fulfillment
of the requirements for the Degree
of
Master of Science in Engineering Geology
in the
University of Canterbury
by
P. J. Horrey.

University of Canterbury
1989

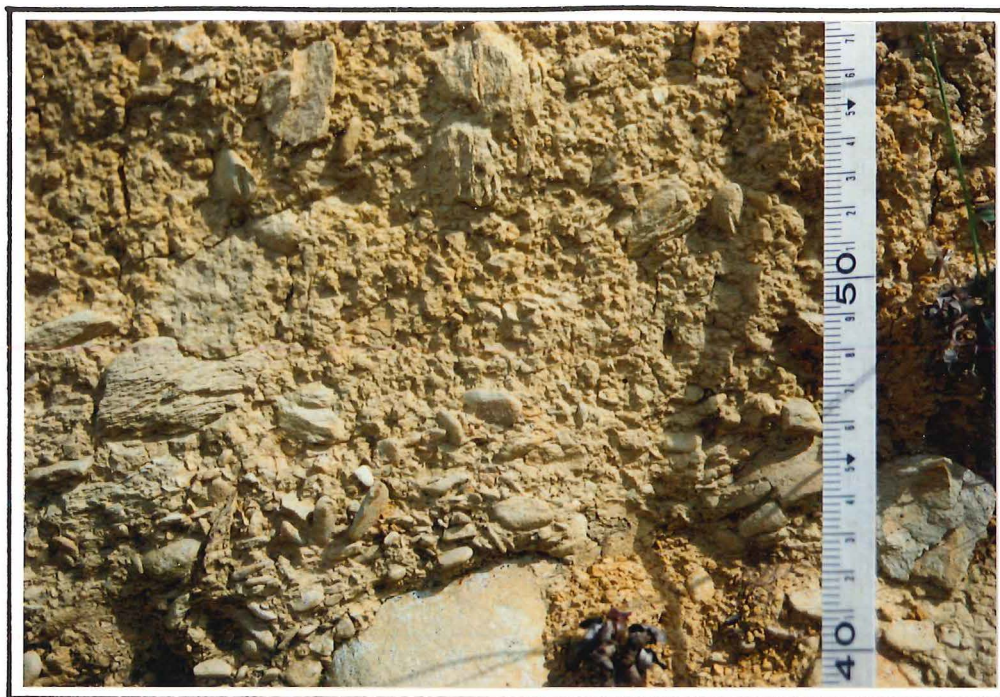
FIGURE 2.1. Greywacke colluvium; Poorly sorted angular blocks in a silty clay matrix.

Most steeper slopes in the study area (with the exception of very limited bedrock outcrops), are covered with a 1-2 metre veneer of colluvium. This material consists of moderately to highly weathered poorly sorted angular bedrock blocks ranging from small cobbles to 200 mm blocks set in a silty clay matrix (see Figure 2.1). The colluvium is matrix supported, and sharply overlies the bedrock surface. The contact is often controlled by discontinuous planar joints or fractures (see Figure 2.2).

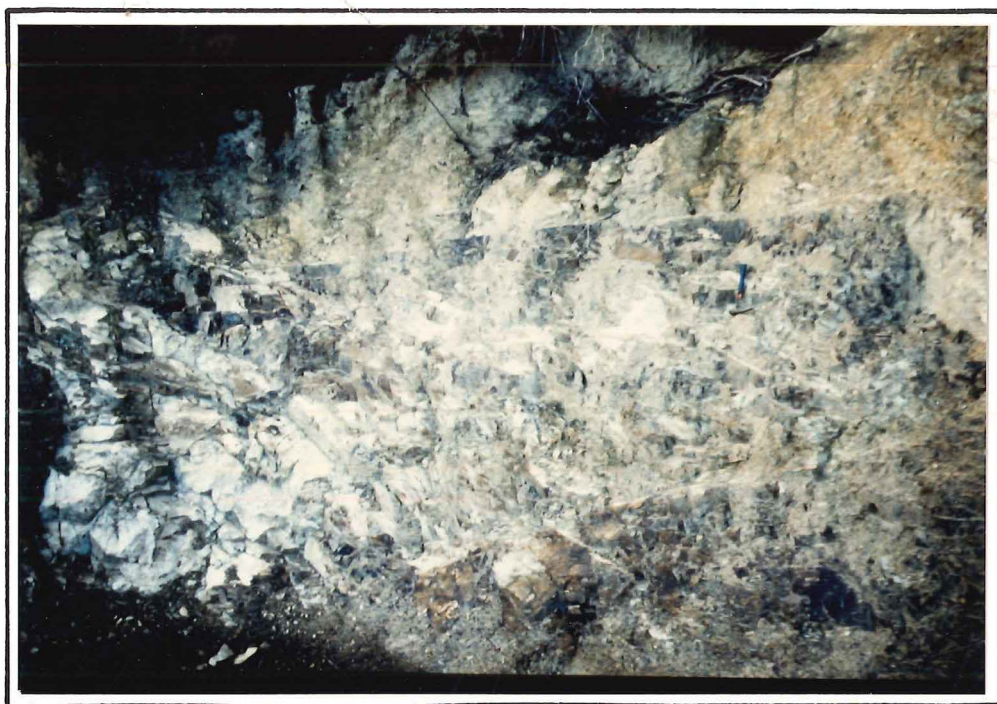
FIGURE 2.2. Greywacke colluvium overlying joint controlled bedrock surface (location JS6; see figure 3.3, map pocket).

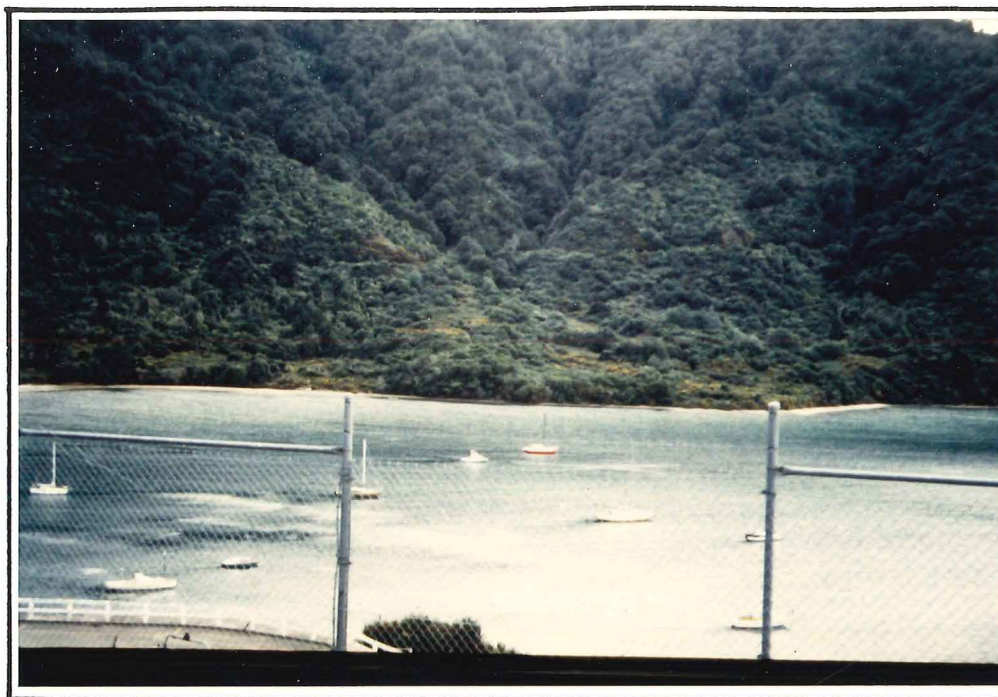
FIGURE 2.3. Large debris fan extending to the shoreline, western Shakespeare Bay.

Near the head of Shakespeare Bay on the western side several large fans have developed out of steep catchments extending toward Mount Freeth (see Figures 2.3 and 2.4). Exposures at the shoreline show poorly sorted angular blocks of slightly to moderately weathered high grade schist set in a very well consolidated clay rich matrix. This material is matrix supported, and no imbrication or preferred orientation of schist blocks is observed. This suggests that these fans have developed as a result of a number of debris flow events. The term "debris avalanche" may be used

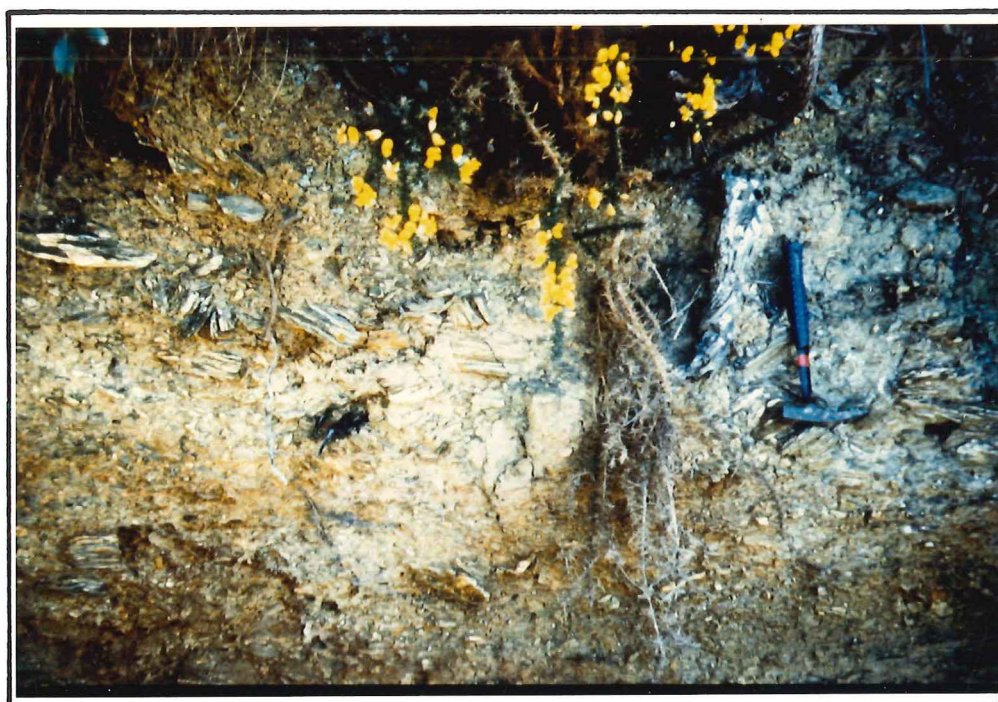
FIGURE 2.4. Schist-derived debris flow deposits exposed at the shoreline of the Shakespeare Bay fan.

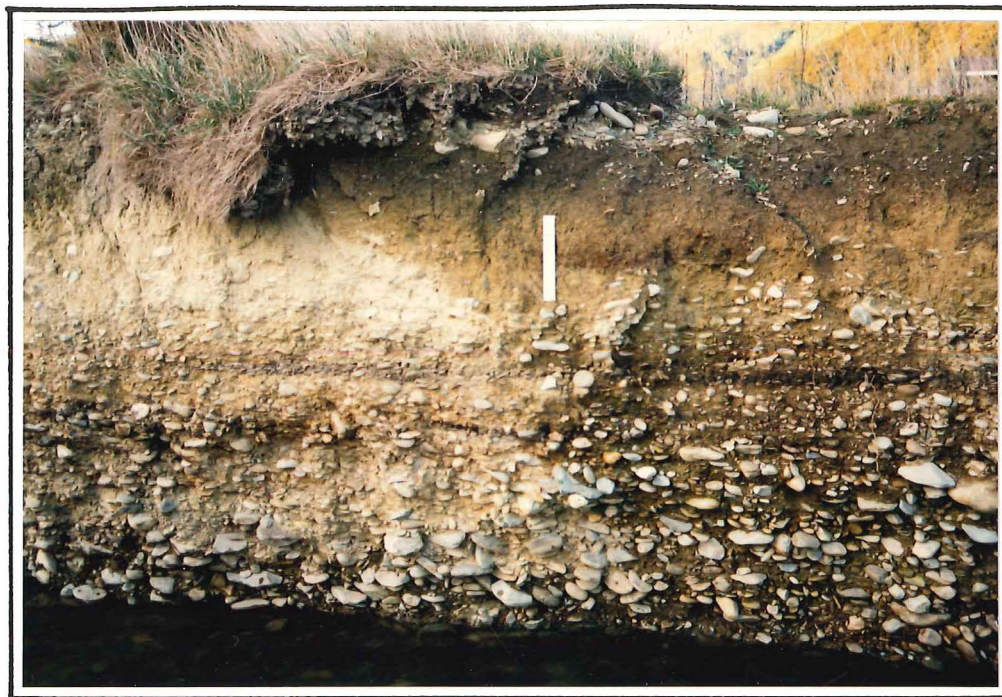
FIGURE 2.5. Imbricated moderate to fine alluvial gravels exposed in the stream bank, lower Waikawa Stream.

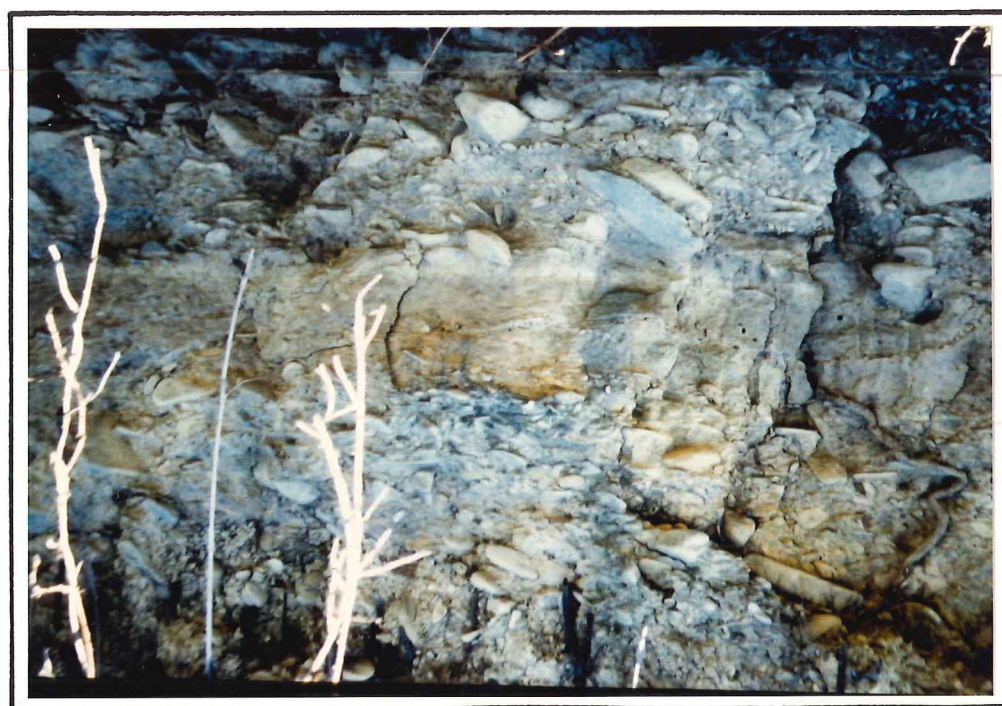
FIGURE 2.6. Coarse alluvial gravels with silt horizon underlying W_3 surface, Waikawa Stream.

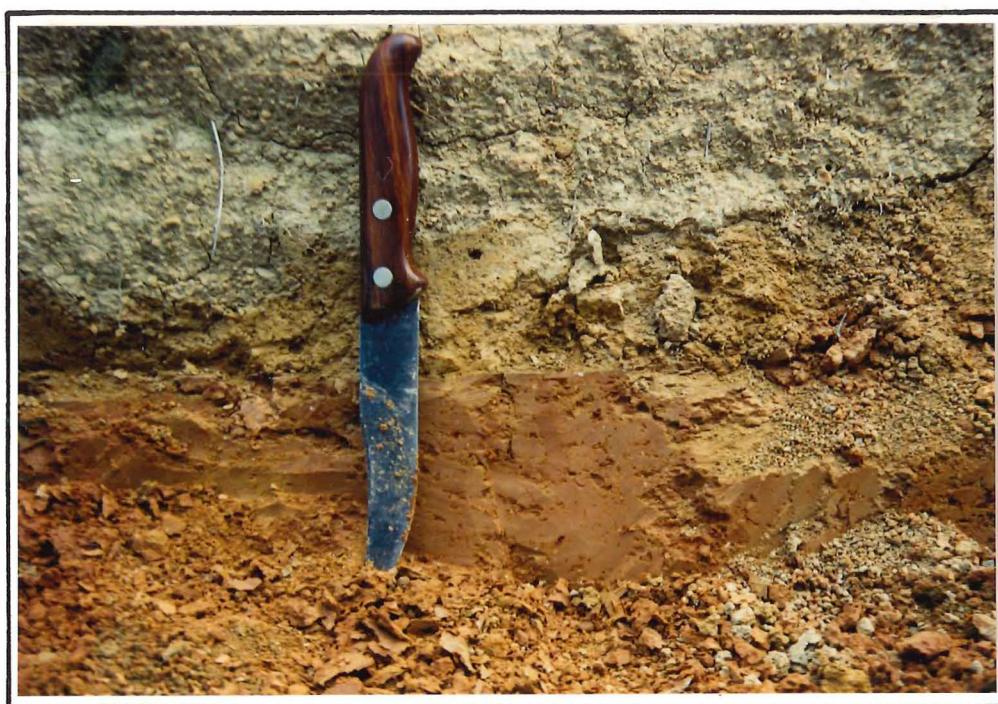
FIGURE 2.10. Late Otiran - Holocene loess and slope-wash deposits sharply overly a pre-Otiran red weathered bedrock surface, Ranui Street, Waikawa.

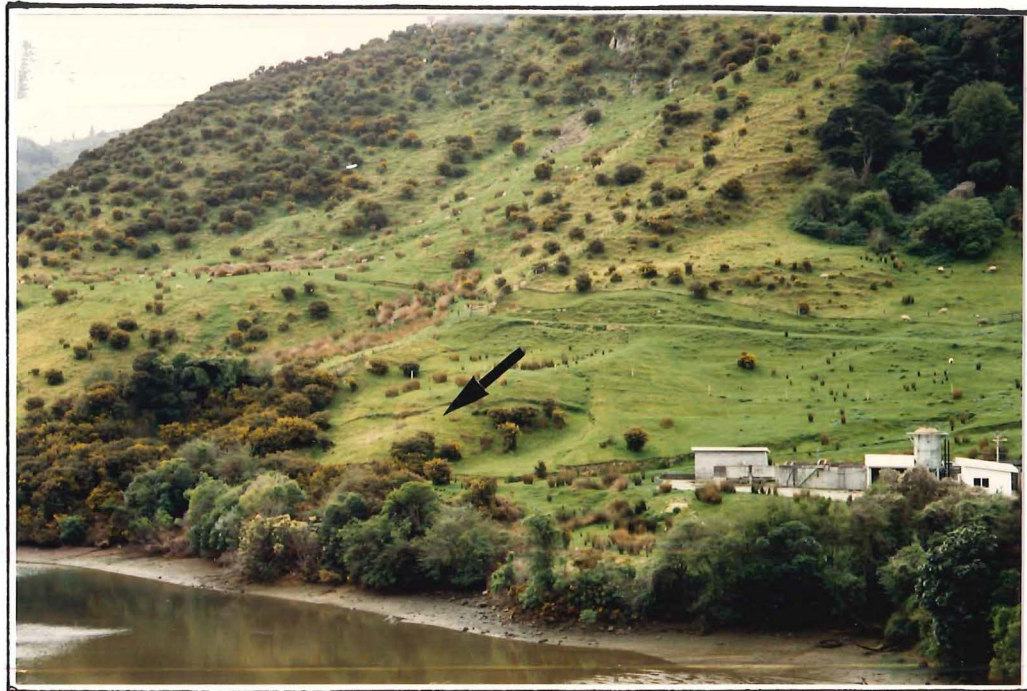
FIGURE 3.15. Landsliding in colluvium, eastern Shakespeare Bay.

A number of shallow colluvial failures have occurred on the Shakespeare Bay slopes, the largest and most recent being located directly below a cut track adjacent to the waste treatment buildings, and extending to the shoreline (see Figure 3.15). Such failures are also common on the hills surrounding Picton and Waikawa, particularly in areas where natural slope drainage has been disturbed by road or track construction.

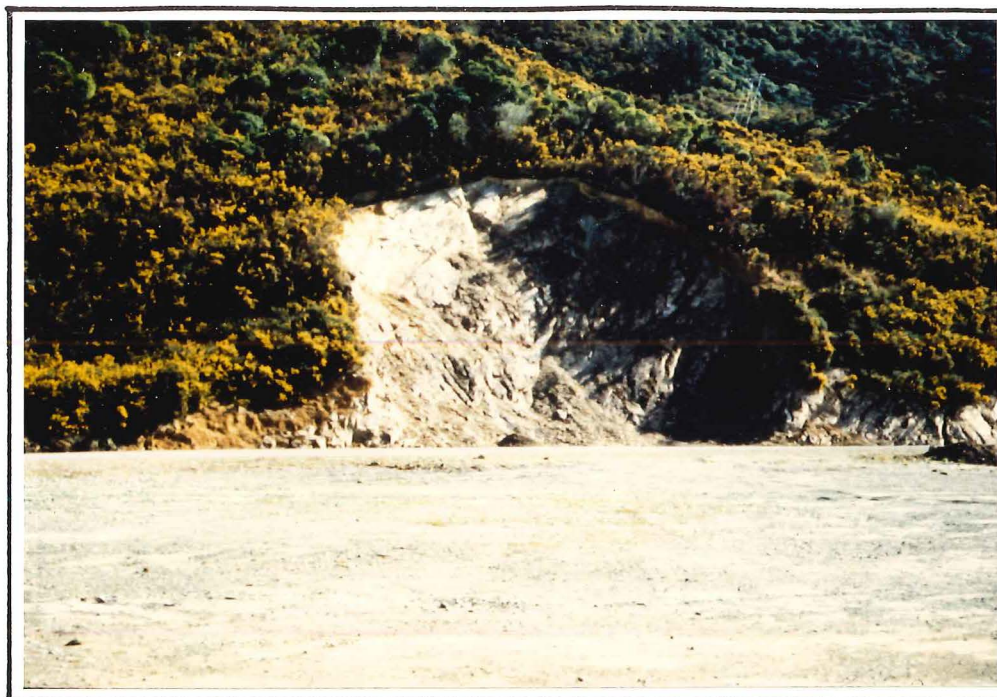
FIGURE 3.19. Bedding plane failure in cut batter, Waikawa Marina (location WML, see figure 3.2, map pocket).

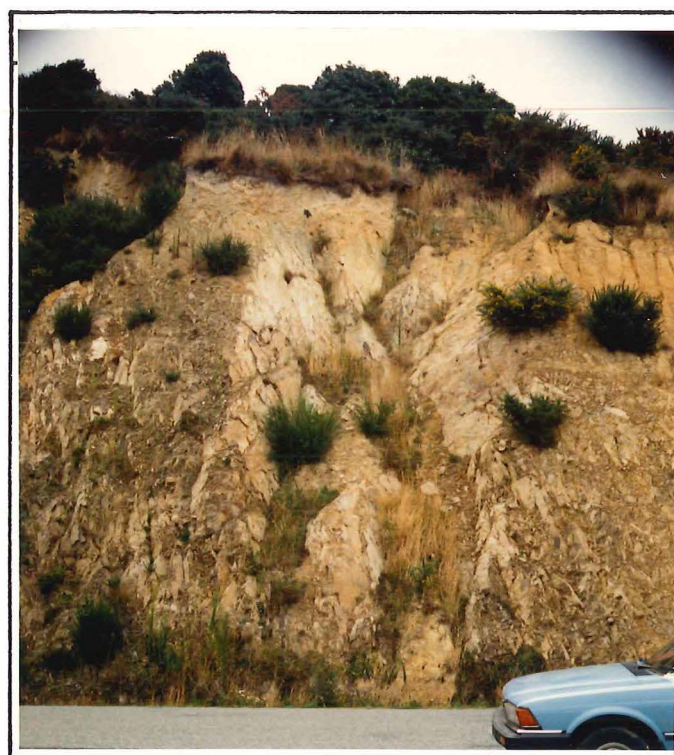
FIGURE 3.20. Joint controlled wedge failure in road batter, Waikawa Marina.

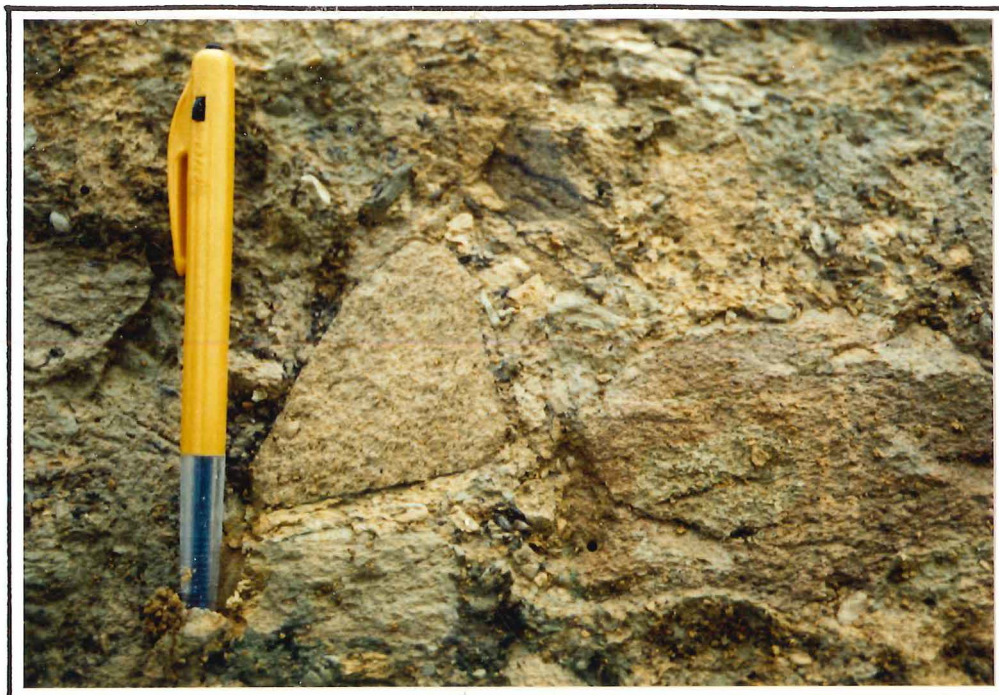
FIGURE 3.22. Completely weathered alluvial gravels of the W_0 aggradation phase exposed at location WR2, Waikawa Road (see figure 3.2, map pocket, for location).

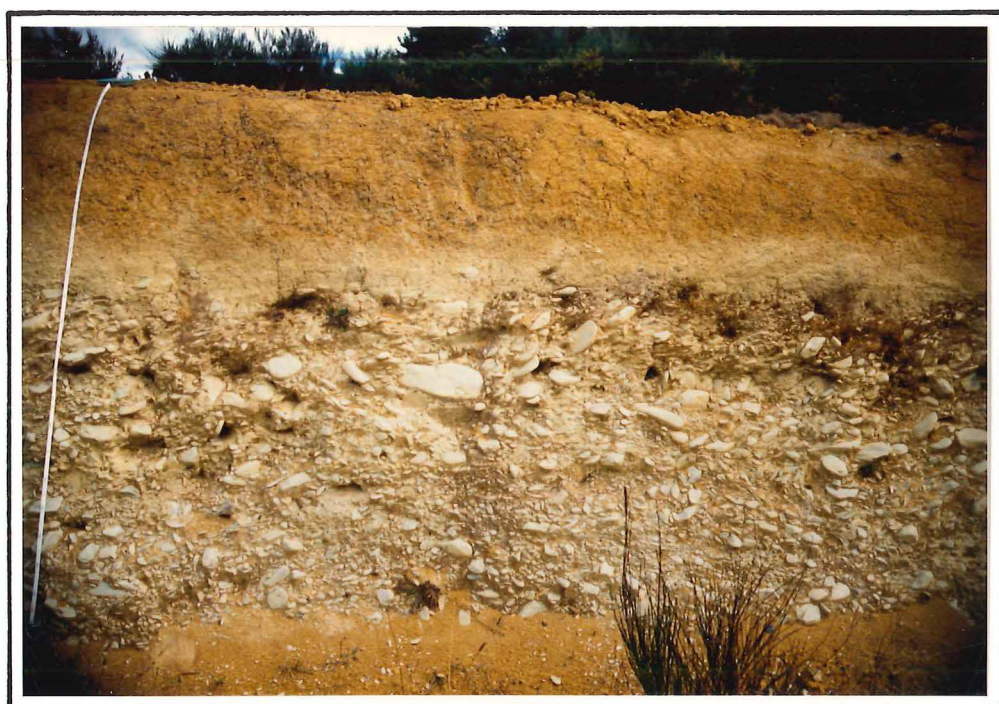
FIGURE 3.23. Slightly to moderately weathered alluvial gravels of the W_1 aggradation phase exposed at location WR1, Waikawa Road (see figure 3.2, map pocket, for location).

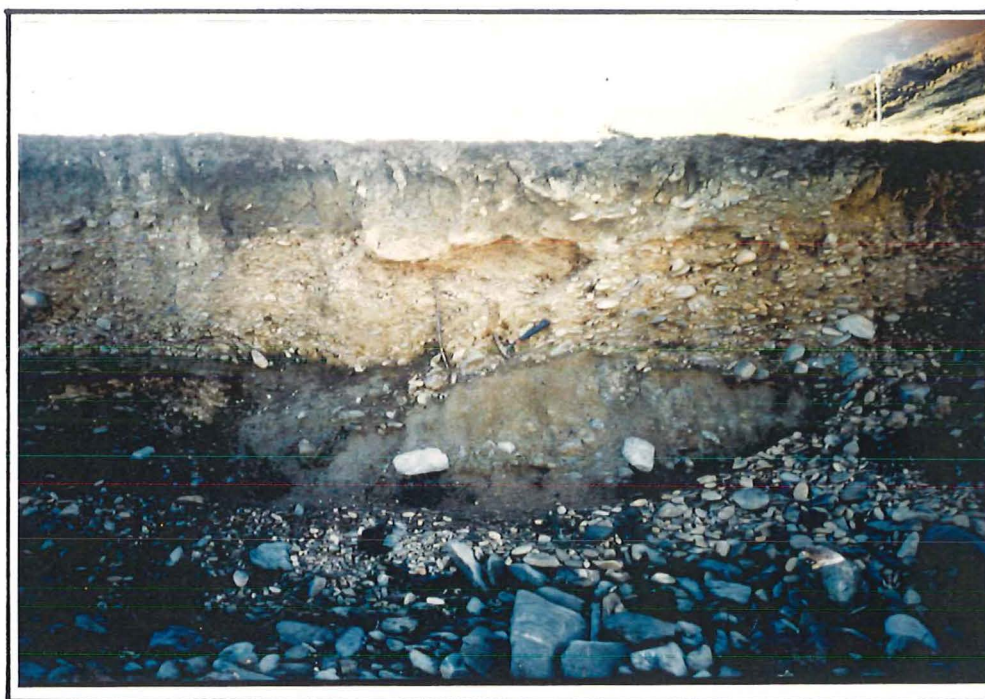
FIGURE 3.25. Small scale faults observed in Late Holocene alluvial gravels, Waikawa Stream (W_4 surface). This locality is within 100 metres of the inferred position of the Waikawa Fault.

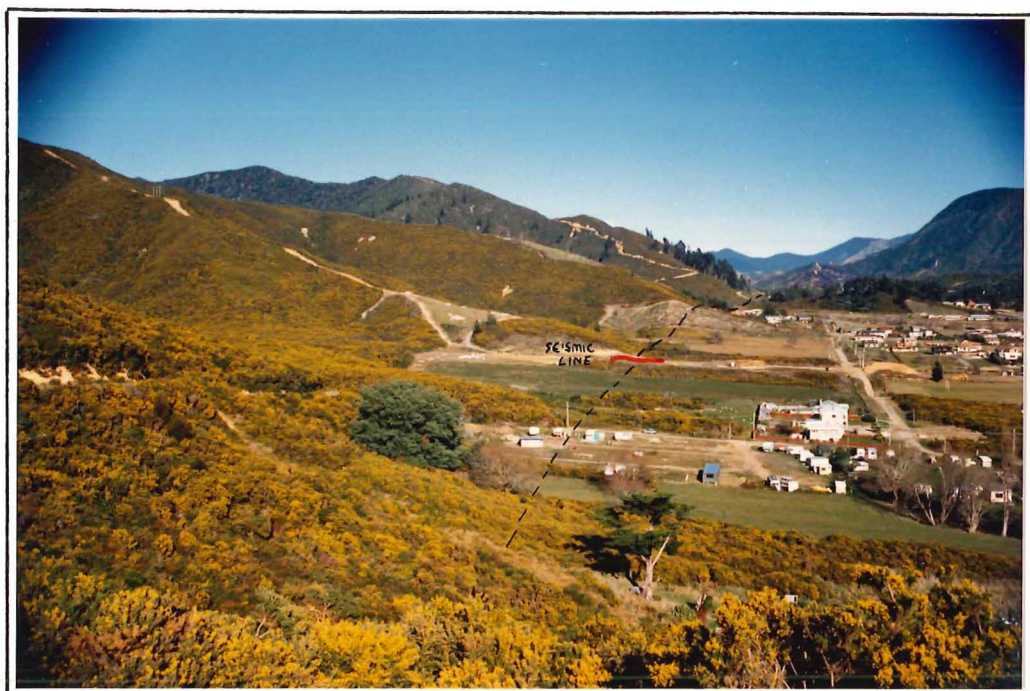
FIGURE 3.26. Eastern Waikawa residential area, showing the degraded trace of the Waikawa Fault.

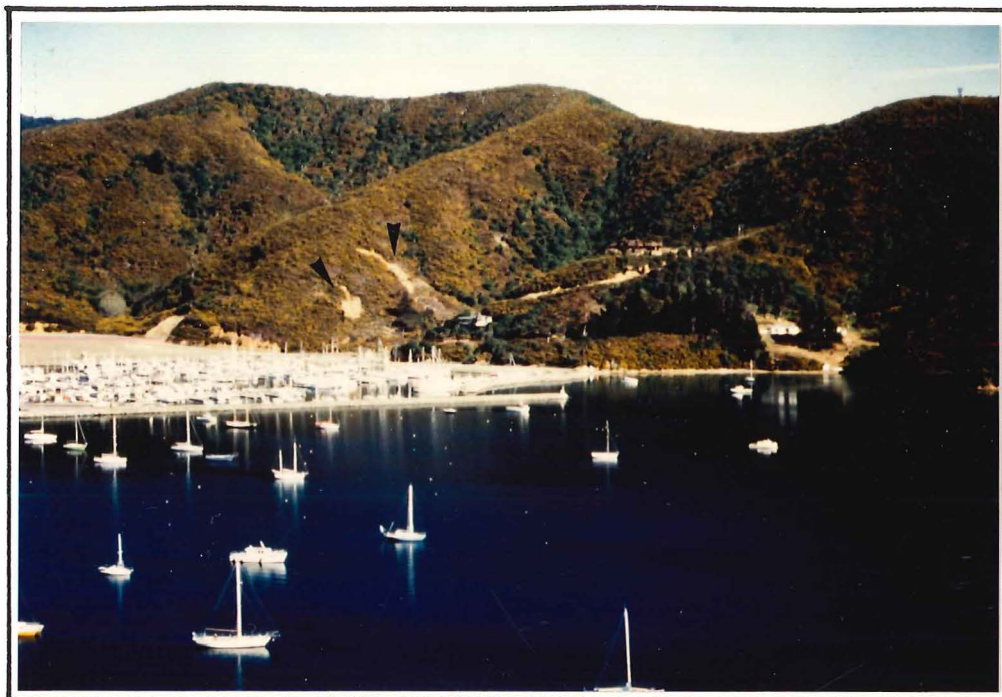
FIGURE 4.8. Landslides in natural ground (arrowed) behind the Waikawa Marina.

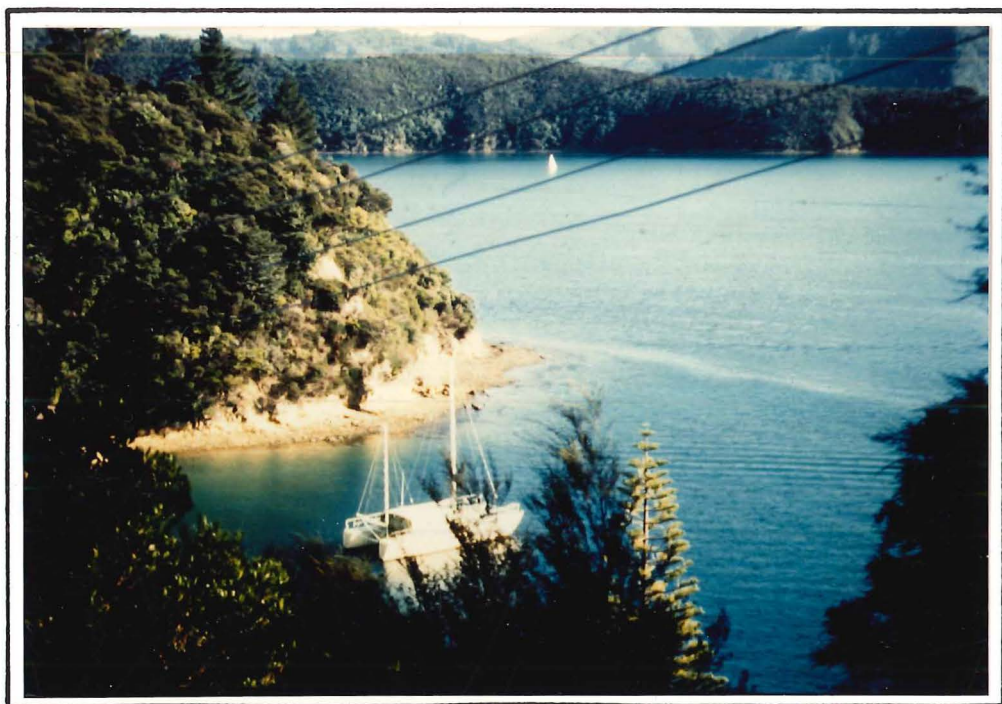
FIGURE 4.9. Coastal erosion, eastern Waikawa Bay.

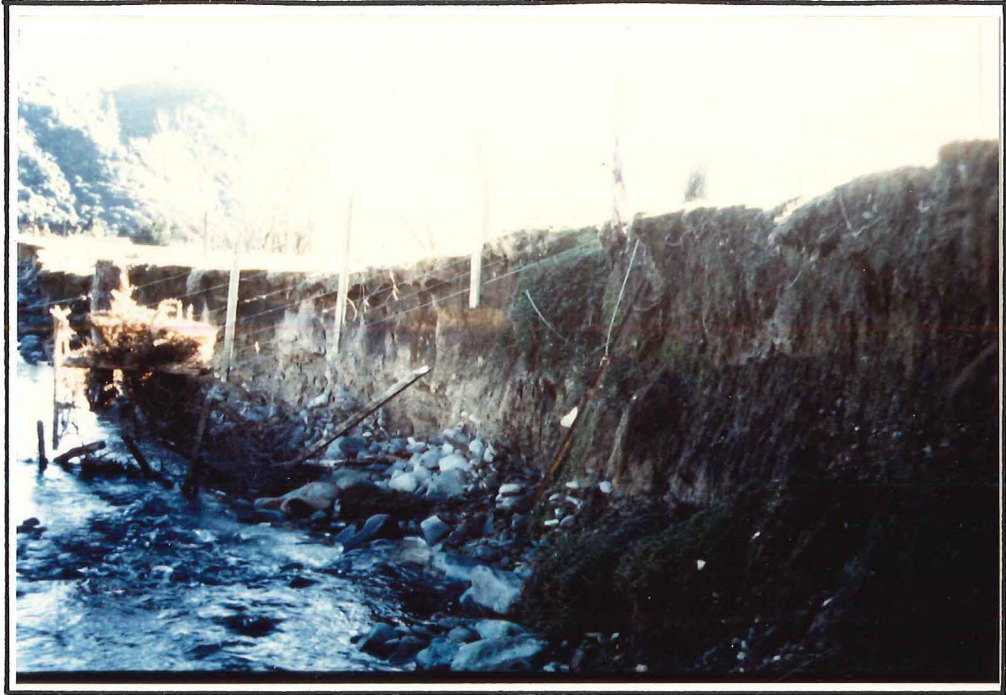
FIGURE 4.10. Stream bank erosion, Waikawa Stream.

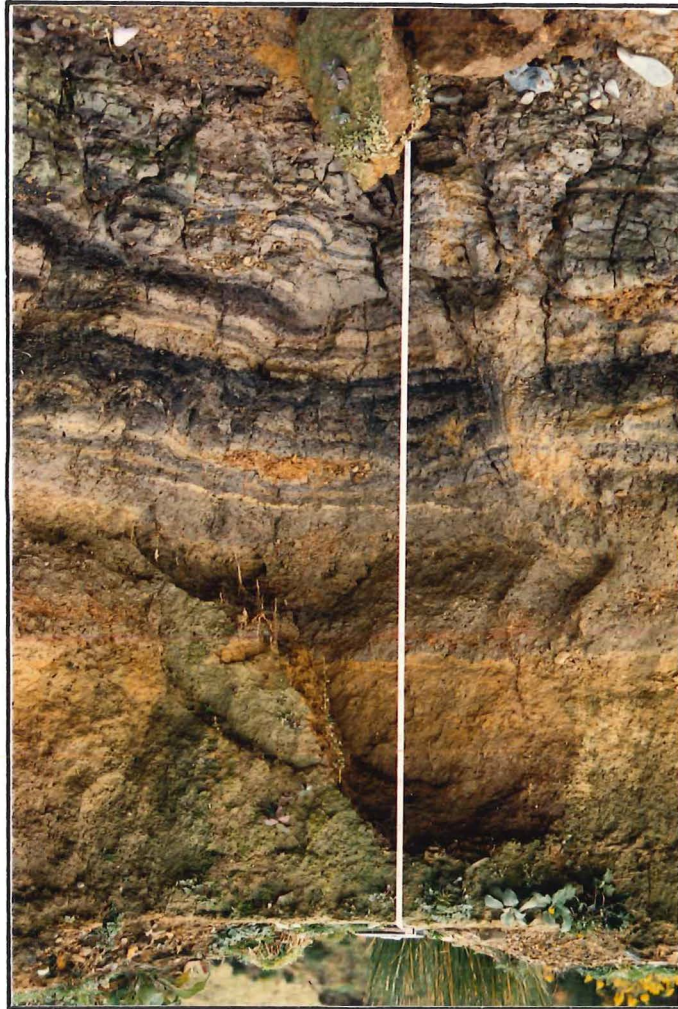
Buried swamp deposits at location WS1, Waikawa Stream (see measured section).
